(6) National Dam Inspection Program.
Elmhurst Dam (NDS ID 296), Susquehanna
River Basin, Roaring Brook, Lackawanna
County, Pennsylvania. Phase I Inspection
Report.

ELMHURST DAM

PHASE I INSPECTION REPORT
NATIONAL DAM INSPECTION PROGRAM

(11) MAY 1978

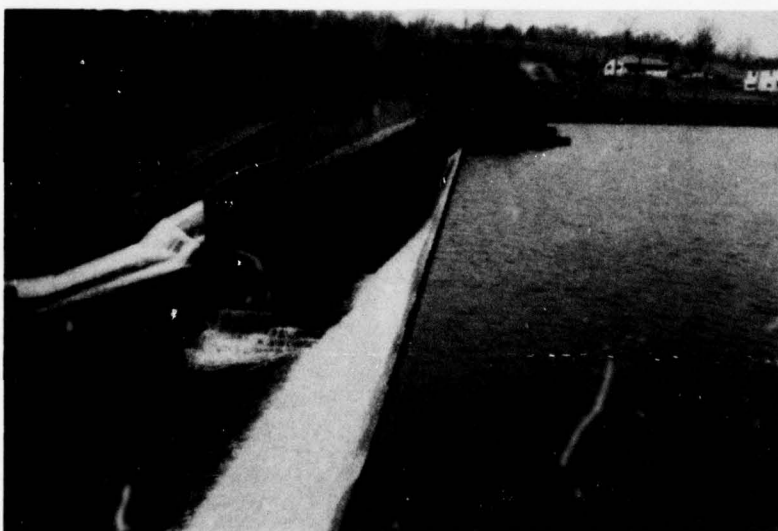
To the right of the masonry gravity section of the dam is a masonry gravity spillway that is 153.3 feet long and 65 feet high (Photographs B and G). The left side of the spillway is founded on rock and the right side is founded on a concrete footing that was placed on clay. In 1916, the spillway was strengthened with 38 1-1/2-inch diameter, 32-foot long, twisted steel bars grouted in 3-inch diameter holes located 1.5 feet from the upstream face. The masonry gravity spillway section and strengthening details are shown on Plates 3 and 4, respectively.

B. Masonry Gravity Spillway and
Concrete Chute Spillway

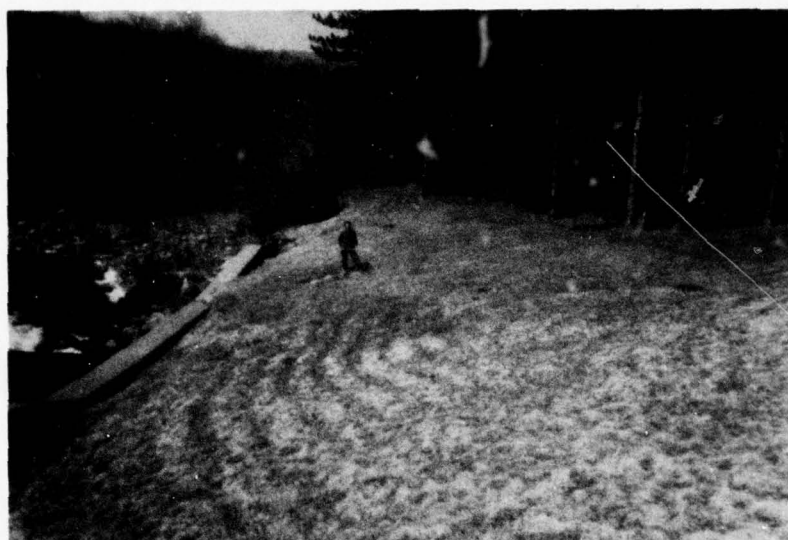
b. Dam. The dam embankment was maintained adequately. The sod on the downstream surface was intact and well maintained. The only noticeable problems were with the surface runoff control system at the right abutment. A 40-foot long, 36-inch diameter BCCMP, which is designed to receive flow from a ditch, had flow under it. A defective pipe junction near the midpoint of the pipe has resulted in the formation of an 18-inch diameter sinkhole. There were also signs of inadequate capacity of the system. Uncontrolled overland flow has apparently produced an eroded area just beyond the toe of the embankment. This area was filled with some large stones (Photograph E). The uncontrolled flow apparently exits over the most downstream monolith of the concrete chute spillway right wall and along the ground surface parallel to the back face of the wall. There was some erosion behind the end of the wall to a maximum depth of 4 feet (Photograph E). A manhole that is located at the toe of the embankment has two pipes entering and one leaving it. A 4-inch diameter pipe, identified by the Owner as a spillway wall drain, had an accumulation of clayey soil at its outlet. The soil was cleared away and a small, clear flow was observed. Probing the pipe indicated additional accumulation of soil along its length. The second pipe entering the manhole, an 8-inch diameter pipe entering on the uphill side from the general direction of the right abutment, had an estimated discharge of 5 to 10 gpm of clear water. Its source was not determined. Outflow from the manhole entered the midpoint of the aforementioned 36-inch BCCMP.

a. Dam. The deficiencies of the surface runoff system were not serious at the time of the inspection. Although evidence of improper functioning and inadequate capacity were observed, the damage has been of a local, noncritical nature, and results, primarily, only in a poor appearance. Complete neglect over a long period of time, however, could result in hazard to the right spillway wall or to the embankment. The accumulation of clay at the end and along the length of the spillway wall drain indicates that some migration of soil has taken place. While not appearing serious at the present time, the effectiveness of the drain might be impaired.

E. Area Adjacent to Embankment
Damaged by Surface Runoff

- (6) Perform repairs on surface runoff control system, outlet channel left wall, concrete apron joint below masonry gravity spillway, and hole at base of concrete chute spillway right wall.

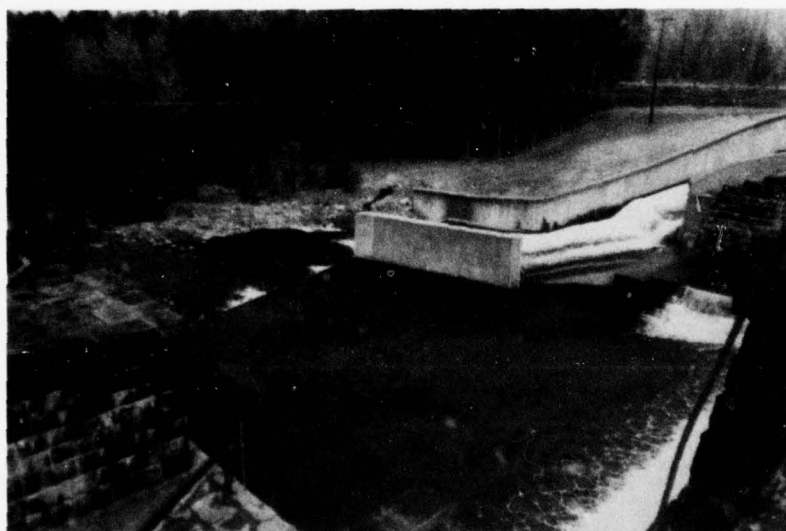
but no differential movement was noted. The concrete apron at the bottom of the masonry gravity spillway (Photograph F) was in excellent condition, except that joint filler was missing between two slabs near the right side. Two leakage areas were on the downstream face of the short, masonry gravity section of the dam that is adjacent to the left side of the masonry gravity spillway (Photograph K). The leakage ran onto the roof of the gatehouse and then into the earthfill along the left side of the gatehouse.

F. Concrete Apron of Masonry Gravity Spillway
and Downstream Channel

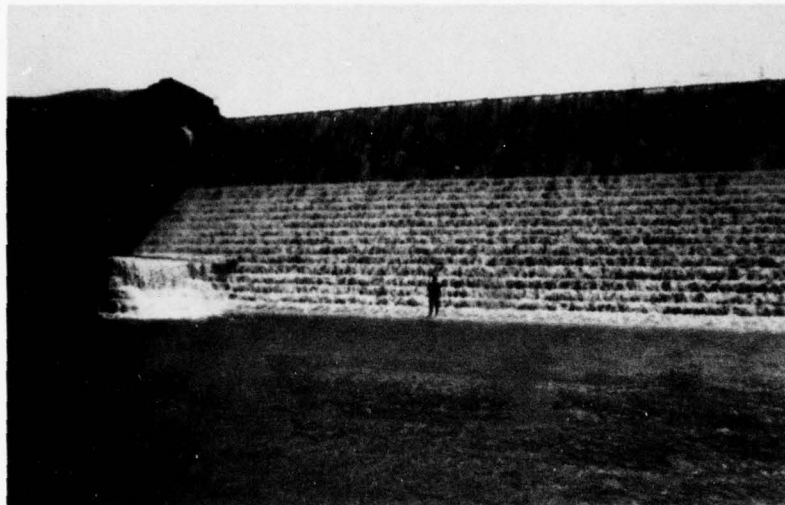
(1) The downstream face of the masonry gravity spillway (Photograph G) had too much flow over it to be examined in detail. However, no blocks of stone were missing. The upstream face has earthfill against it and cannot be inspected. The stone masonry and mortar joints of the spillway walls adjacent to the spillway were apparently sound. The outlet channel left wall, which is along the spillway apron, had two leaks, both near the base. Clear water was being discharged from the leakage points. An 18-inch diameter sinkhole was in the wall backfill above one of the leakage points. Near the downstream end of the wall, a portion that had been repaired with concrete had two vertical cracks and some spalling of the concrete. The cracks extend through the wall

G. Masonry Gravity Spillway and
Concrete Apron

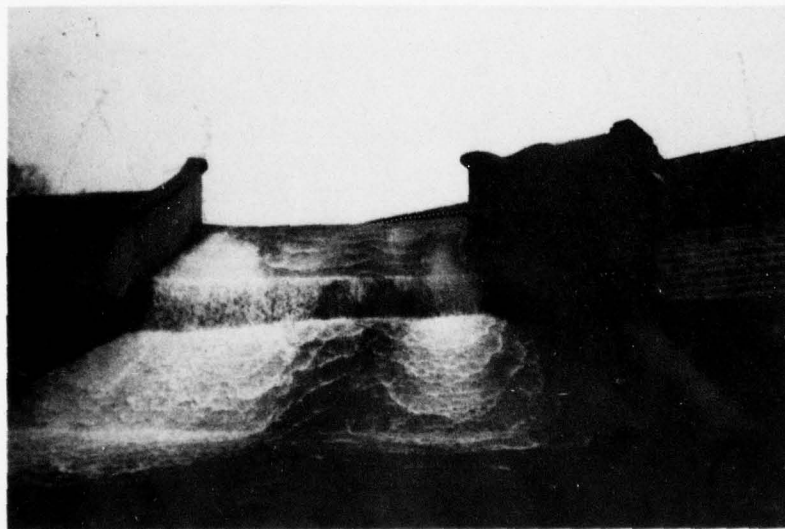
(2) The concrete chute spillway (Photograph H) was in excellent condition, and it exhibited only normal, uniform wear. All monolith joints were properly sealed. However, the following observations were made in the vicinity of the second and third right wall monoliths from the downstream end: three fine diagonal cracks, wider monolith joint separation than at other monoliths, spalling at joint on back face, a 5-inch diameter hole at joint on front face at apron level that extended 2 feet back under the wall, possible differential movement indicated by 1/2-inch monolith misalignment at top of wall, and a 5-foot diameter area on the backfill 6 inches lower than adjacent areas located about 5 feet back of the middle of the second monolith. Apparently, however, none of these deficiencies has affected the satisfactory performance of the wall. Photograph L shows the location of problem area.

H. Concrete Chute Spillway and Apron

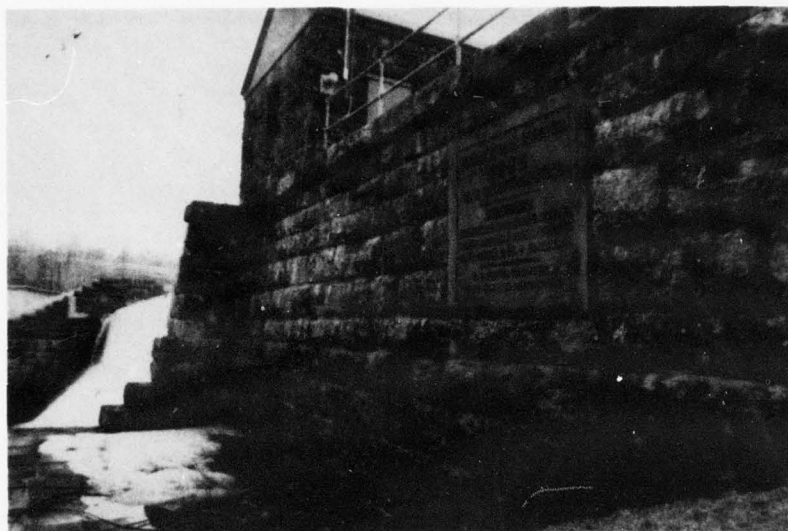
b. Design Features. The drawings indicate that the main section of the dam is a combination of earth embankment at the right abutment and masonry gravity section at the left abutment. A general plan is shown on Plate 1A. The embankment is a homogenous earthfill structure with a central masonry core wall. The bottom of the core wall is 6 to 10 feet below the original ground line. The core wall is on concrete footings which are founded on clay. The embankment section is about 160 feet long and 64 feet high at the original streambed. Embankment sections are shown on Plate 2. The masonry gravity section of dam is about 70 feet long and about 75 feet high and is founded on rock (Photograph K).

K. Downstream Face of Masonry Gravity Section
and Screen Chamber Building

- (1) Repair stone masonry to eliminate leakage through downstream face of gravity section of dam, gatehouse walls, and left abutment wall. Repair deteriorated stone masonry along top 3 feet of left abutment wall.

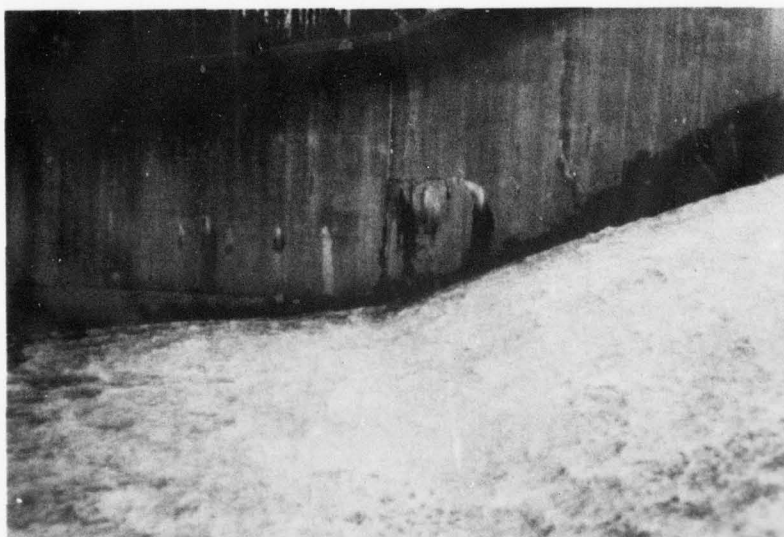
(2) The performance of the right spillway wall has not been affected by the problems that were observed, but it should be noted that the wall is a key feature of the project. If the situation is stable, no hazard exists. However, if the observed conditions are part of an active situation, unsatisfactory performance could result.

L. Right Wall of Concrete Chute Spillway
at Apron

- (3) Repair concrete extensions on right abutment wall and left abutment wall.
- (4) Monitor right wall of concrete chute spillway for movement.
- (5) Evaluate effect of possible improper functioning of concrete chute spillway wall drain with respect to design function. If drain must be functional, install several observation wells in the drain to determine the extent of hydrostatic pressure on the wall and to determine if repairs to the drain are necessary. If installed, monitor wells to see if condition worsens.
